**SUMMARY REPORT
ATOFINA EMERGENCY RESPONSE
RIVERVIEW, WAYNE COUNTY, MICHIGAN**

UNITED STATES ENVIRONMENTAL PROTECTION AGENCY
Region V Emergency Response Branch
9311 Groh Road
Grosse Ile, MI 48138

Roy F. Weston, Inc.
750 East Bunker Court
Vernon Hills, IL 60061

Date Revised	9 September 2002
TDD Number	0107-008
Document Control Number	133-2A-ABYS
Contract Number	68-W7-00-119
START Program Manager	John Thorsen, P.E.
Telephone No.	(847) 918-4102
U.S. EPA On-Scene Coordinator	Michelle Jaster
Telephone No.	(734) 692-7683

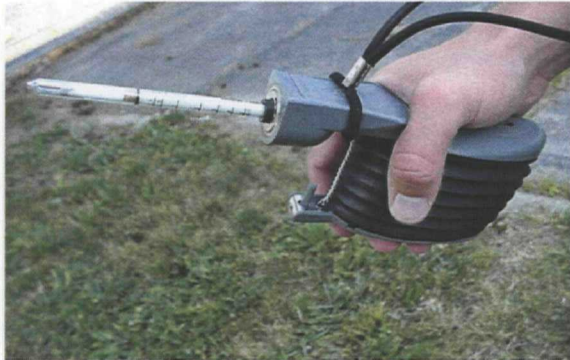
Draeger colorimetric tubes (Draeger) - Draeger colorimetric detector tubes consist of a glass tube filled with media that contains an indicating chemical. The glass tube is connected to a piston cylinder or bellows-type pump. A known volume of air is pulled at a predetermined rate through the indicator chemical in the tube. The suspected chemical of concern (if present) will react with the indicator chemical and produce a stain whose length is proportional to the concentration of the

chemical of concern in the atmosphere. Detector tubes are normally compound specific; there are different tubes for different chemicals. During the ATOFINA Plant incident, Draeger tubes were used to monitor for the chemicals methyl mercaptan, chlorine, sulfur dioxide, and acids. Methyl mercaptan and chlorine-specific detector tubes were utilized because these chemicals were involved in the fire at the Plant. Sulfur dioxide-specific detector tubes were utilized because sulfur

Draeger tubes and Draeger pump

dioxide is a byproduct of the combustion of methyl mercaptan. Acid detector tubes were utilized because both sulfur dioxide and chlorine can react with moisture to form acids (sulfuric acid and hydrochloric acid). The acid detector tubes are generic and only indicate the presence or absence of acids.

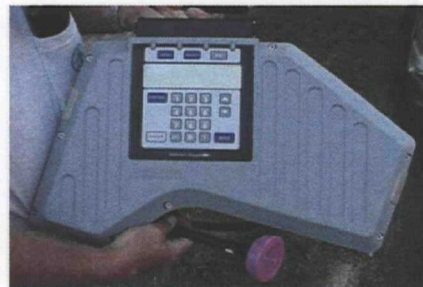
Miran 205B Series SapphIRe (SapphIRe) - The SapphIRe is an infrared imaging analyzer capable of detecting concentrations of various specific chemicals at parts per billion (ppb) detection levels. The SapphIRe was used at the ATOFINA Plant incident to monitor for sulfur dioxide, a byproduct of the combustion of methyl mercaptan.

Miran 205B Series SapphIRe

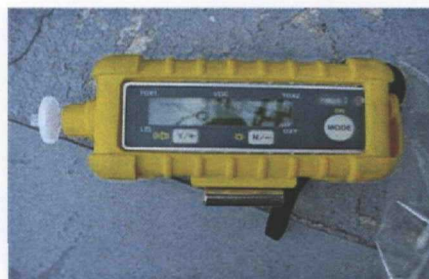
Multi-Rae (photo ionization detector [PID]) - A PID utilizes a light source (ultraviolet lamp) to ionize organic compounds within the instrument's detection range. The electronic impulse that is subsequently generated is displayed as a reading of total volatile organic compounds (VOCs) in the atmosphere. The Multi-Rae was used at the ATOFINA Plant incident to monitor for total VOCs. Because total VOC readings collected could include compounds not directly related to the ATOFINA fire, chemical-specific Draeger tubes were also utilized during the response action to verify the presence or absence of methyl mercaptan in the atmosphere.

Multi-Rae

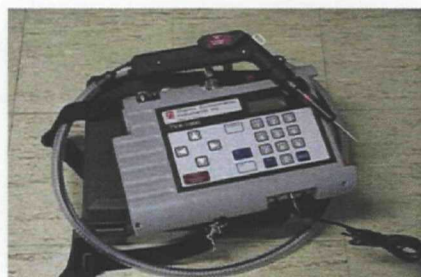
TVA 1000 (flame-ionization detector [FID]) - A FID utilizes a hydrogen flame to ionize organic compounds. The electronic impulse that is subsequently generated is displayed as a reading of total VOCs in the atmosphere. The FID and PID differ in that the source used to detect VOCs is either a flame or a lamp. In addition, different VOCs can be detected by the different instruments. The TVA 1000 was used at the ATOFINA Plant incident to monitor for total VOCs. Because total VOC readings collected could include compounds not directly related to the ATOFINA fire, chemical-specific Draeger tubes were also utilized during the response action to verify the presence or absence of methyl mercaptan in the atmosphere.

TVA 1000

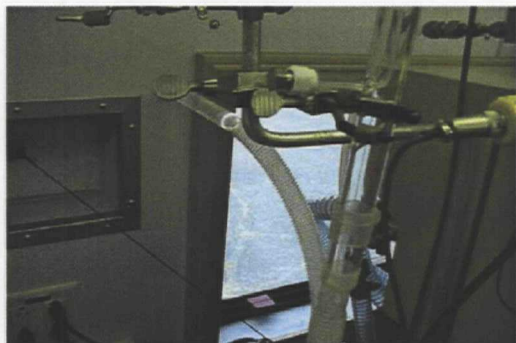
Air monitoring port in TAGA vehicle

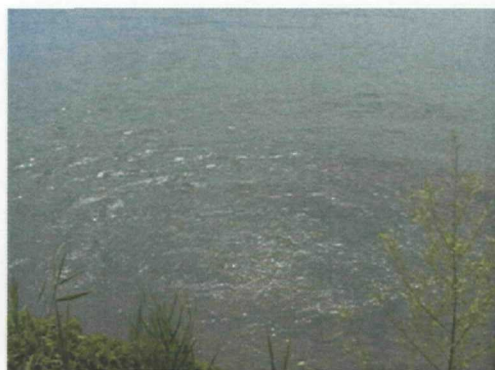
Millions of gallons of water were applied to the ATOFINA Plant to extinguish the fire and cool the adjacent railcars. The wastewater generated from this effort was discharged to the Trenton Channel of the Detroit River via the Plant's storm water outfall. START members located the Plant's storm water outfall as it entered the Trenton Channel of the Detroit River. START observed water entering the Trenton Channel of the Detroit River from the Plant's outfall; the outfall pipe was located beneath the water surface. Detectable odors were not

Area above the outfall from the ATOFINA Plant into the Trenton Channel of the Detroit River

documented in the vicinity of the outfall. START conducted air monitoring at the Plant's outfall location using the air monitoring equipment. There were no detections recorded on any of the instruments at the outfall; therefore, no results were tabulated for these monitoring activities.

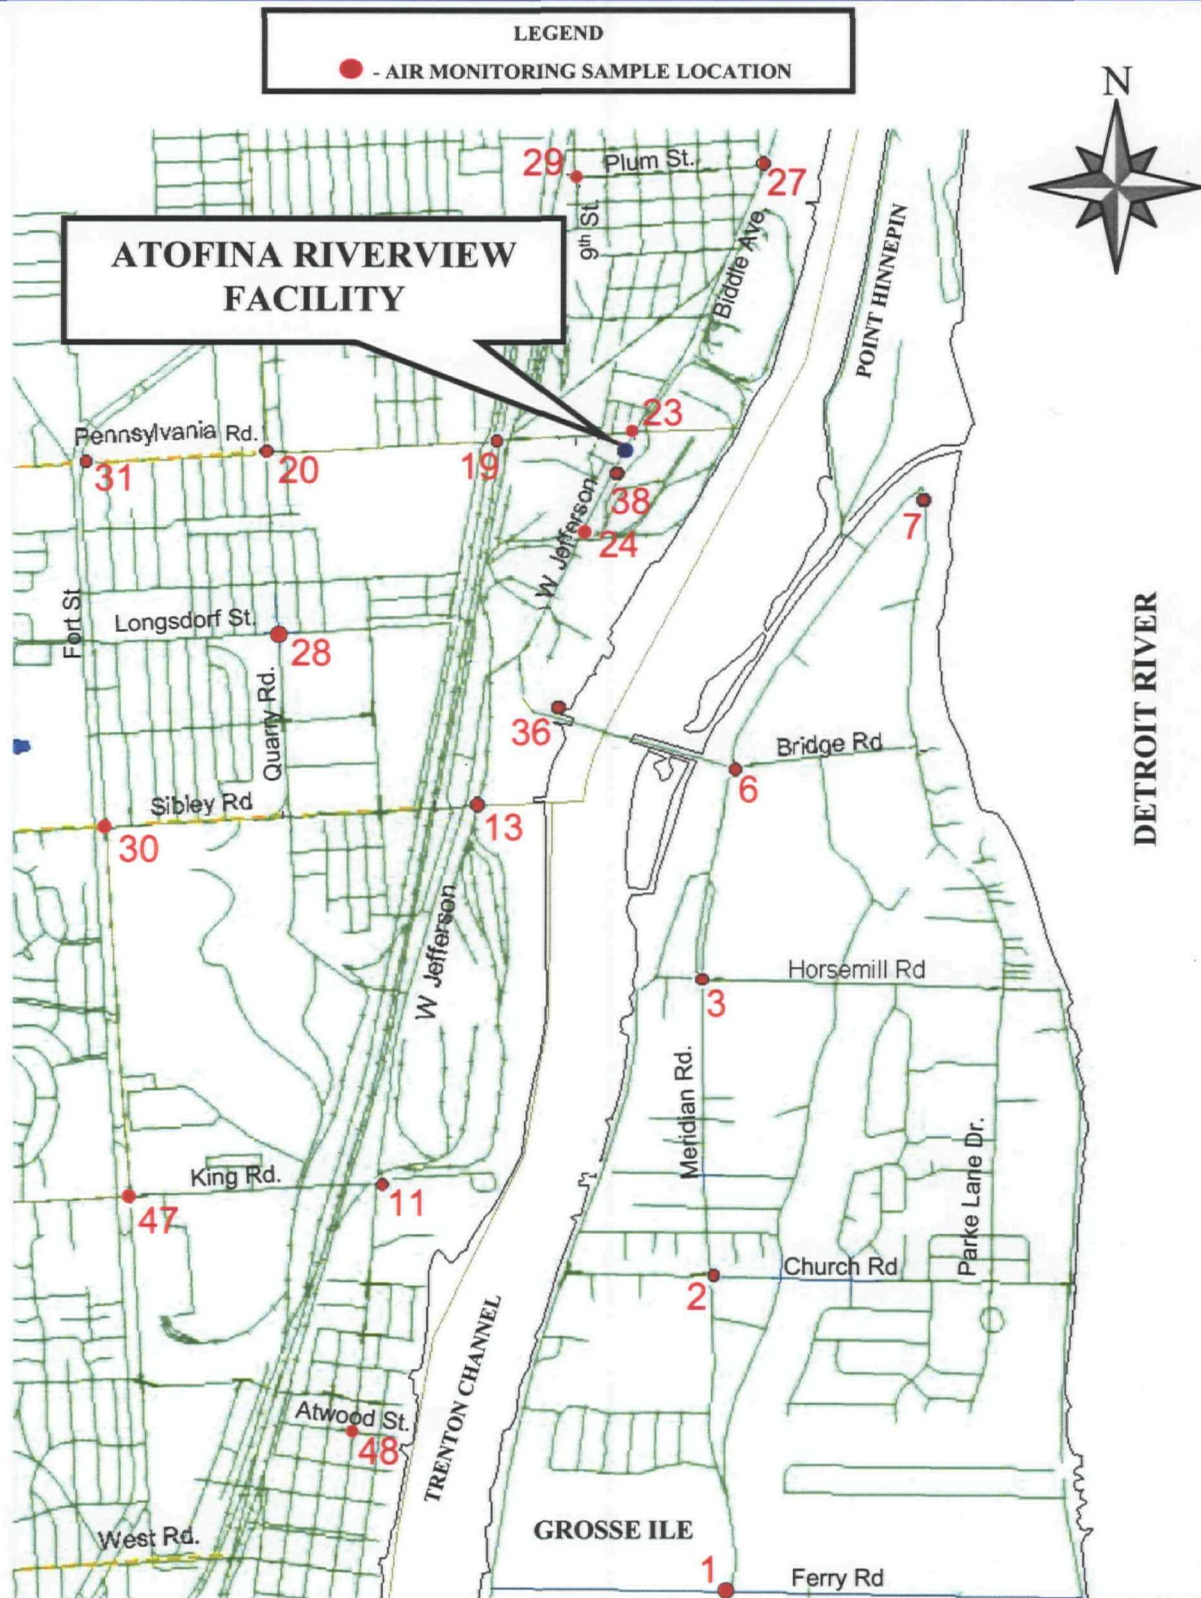
FIGURE 4

AIR MONITORING LOCATIONS FOR ROUND 4 ON 15 JULY 2001

The START teams collected data at the following monitoring locations during the fourth round of monitoring (**Appendix B, Figure 4**):

- 1) Meridian Rd. & Ferry Rd.;
- 2) Meridian Rd. & Church Rd.;
- 3) Meridian Rd. & Horsemill Rd.;
- 6) Meridian Rd. & Bridge Rd.;
- 7) Meridian Rd. & Parke Lane Dr.;
- 11) West Jefferson Ave. & King Rd.;
- 13) Sibley Rd. & West Jefferson Ave.;
- 19) Pennsylvania Rd. & Conrail RR Tracks;
- 20) Pennsylvania Rd. & Quarry Rd.;
- 23) West Jefferson Ave. & Pennsylvania Rd.;
- 24) West Jefferson Ave. between RR Tracks & Pennsylvania Rd.;
- 27) Biddle Ave. & Plum St.;
- 28) Quarry Rd. & Longsdorf St.;
- 29) Plum St. & 9th St.;
- 30) Sibley Rd. & Fort St.;
- 31) Pennsylvania Rd. & Fort St.;
- 36) Tollbridge on the River.;
- 38) West Jefferson Ave. & the southern boundary of ATOFINA;
- 47) King Rd. & Fort St.;
- 48) West Jefferson Ave. & Atwood St.

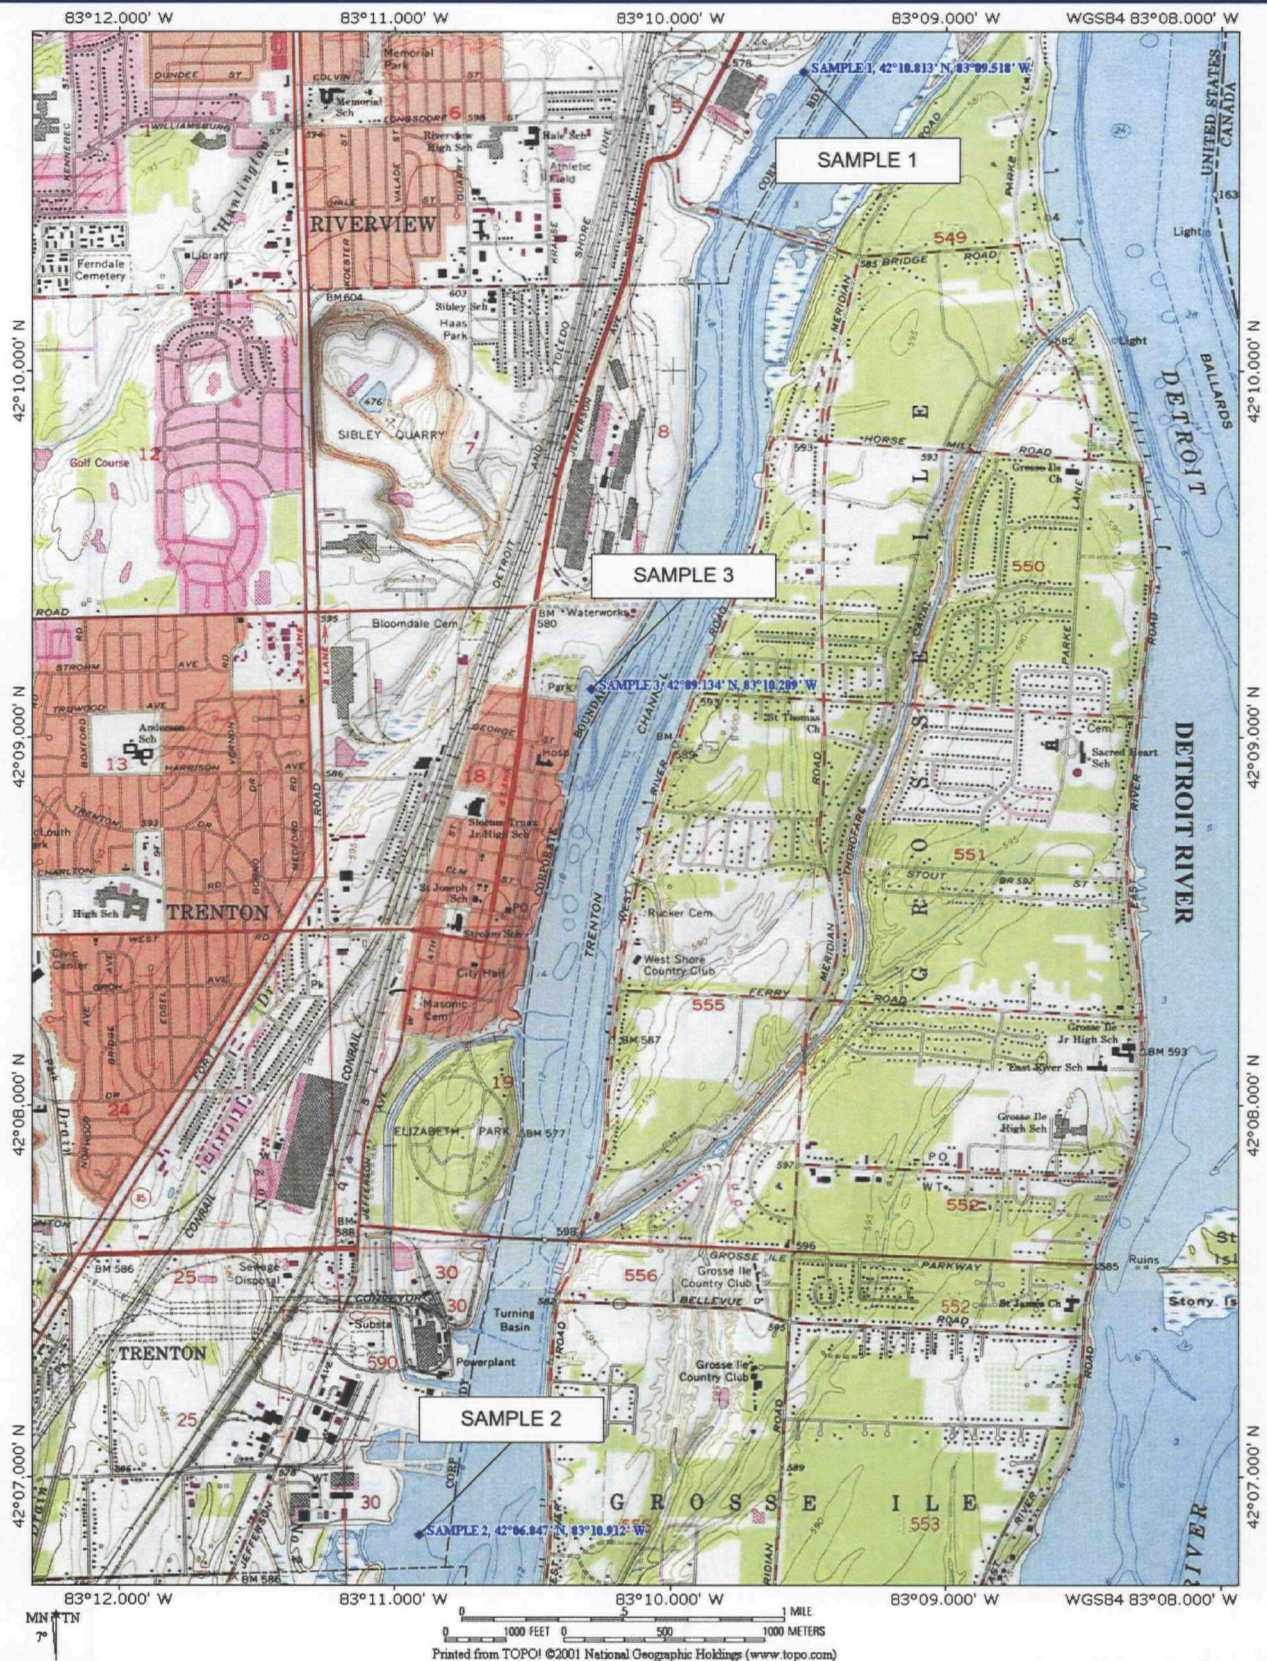
FIGURE 9
SITE LOCATION MAP - WATER SAMPLE S #1, #2, #3

At 1300, START personnel, OSC Jaster, and Mr. Dave Best of the U.S. FWS arrived at the City of Riverview boat launch. The first sample was collected near the ATOFINA Plant outfall. A duplicate sample was also collected at this location. The sample was collected from a depth of approximately 3 feet below the water surface utilizing a glass sampling bottle that had been attached to a polyvinyl chloride (PVC) pole. The sample material was transferred into precleaned laboratory sample bottles. Five volatile organic analysis (VOA) vials and one 8-ounce glass bottle were collected. A field pH reading and GPS coordinates were obtained and recorded in the field log book.

The second sample was collected at 1430 near Humbug Marsh, approximately 6 feet below the water surface. The third sample was collected at 1530 halfway between the Humbug Marsh and the ATOFINA Plant outfall in a location near the former McLouth Steel property. The third surface water sample was collected approximately 6 feet below the water surface. Field pH and GPS coordinates were recorded for both samples. START delivered all samples to Clayton Laboratories in Novi, Michigan, for methyl mercaptan and pH analysis.
